Task

The objective is to carry out research of the effect of the RVS geoactivators on the effectiveness of planned preventive and restoration repairs of friction pairs of different types of machines and mechanisms with developing technologies of their use by using the scientific and technical potential of NP Scientific Technical Association NVTs, Chita, NPO Ruspromremont, St. Petersburg, Transbaikal Railway Transport Institute, Chita State Technical University, Central Scientific Research Laboratory of the Priargun Production Mining-Chemical Association, Automobile Engine and System Test Center of Changchun University of Science and Technology, P.R. China. The research was carried out between April 1999 and December 2002.

REPORT
ON EXPERIMENTAL RESEARCH OF
PISTON COMPRESSOR KT-6EL

REPORT

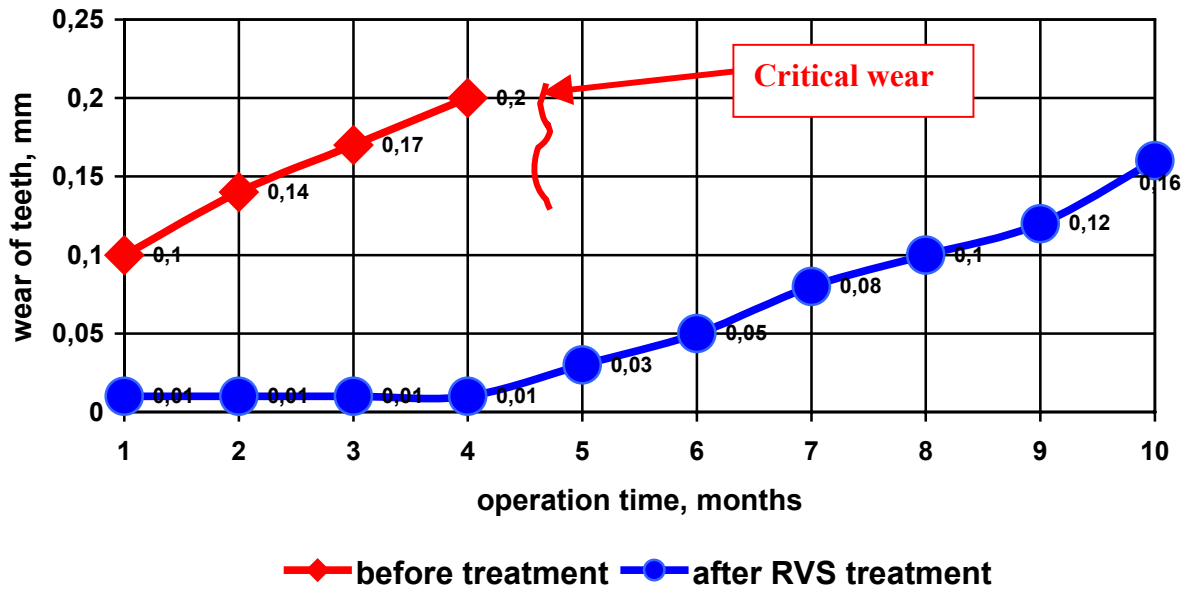
Picture 10: Comparison of wear speed of gearbox wheels when operated without lubricant

A comparative analysis of the wear speed of the gearbox wheels when it was operated without lubricant is shown in Picture 10.

It is necessary to note that, in a straight bevel gearbox, there are no axial loads on the wheels. In bevel gearboxes, due to axial loads, the gear wheels are centred and that kind of a gearbox is better adapted for railway transport use.

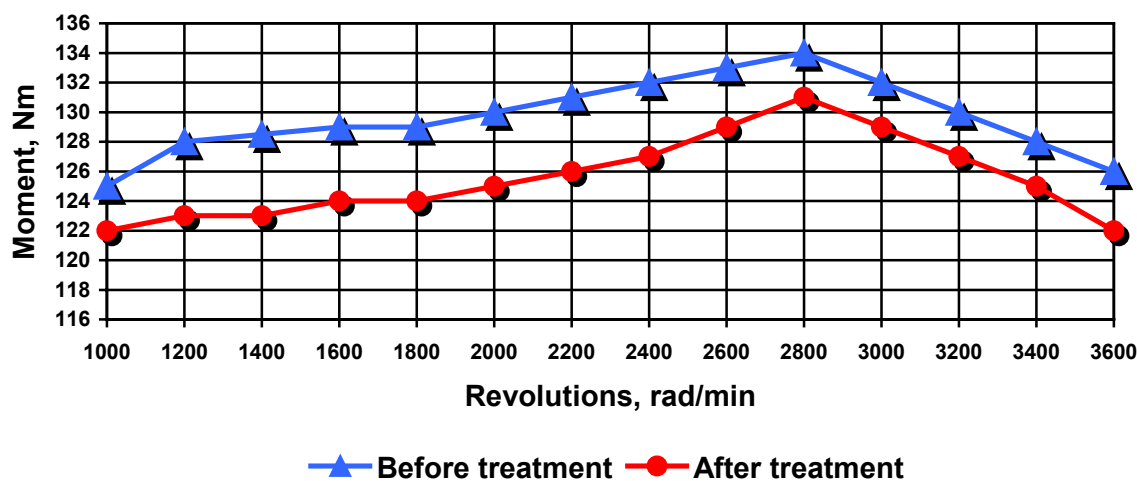
Picture 11: Dependence of resistance moment of motor axle on revolutions

When measuring the parameters in the bench, it was noticed that the gas distribution system of the bench had drawbacks in regulating heat clearances of the pushrods of the inlet and outlet valves. Due to the defect, it seemed to be impossible to carry out reliable measurements of the change of compression in cylinders as a result of the RVS Technology treatment. Due to limited time reserved for the experiment, it was decided to carry out the experiment with the above-named defect. The results of the experiment are shown graphically in Pictures 11, 12, and 13.

The data given above on the experimental researches and the analysis show that using the RVS Technology in internal combustion engines significantly decreases the friction resistance moment in the engine and, as a result, reduces fuel consumption, improves processes of combustion of the fuel and air mixture in the cylinders, which significantly reduces harmful exhausts into the atmosphere.
